Re: Wood shake roofs at Owl Creek Townhomes

Inspect the roofs at Owl Creek Homes in Snowmass Village, Colorado and prepare a brief report to document the existing condition of the roofs along with the expected life of the various roof components. There is a total of 31 roofs within this subdivision. In order to accomplish this, I inspected the subject roof located at 916 Burnt Mountain Drive within the development as a typical example of the condition of the existing roofs.

Owl Creek Homes

916 Burnt Mountain Drive Snowmass Village, CO 81615

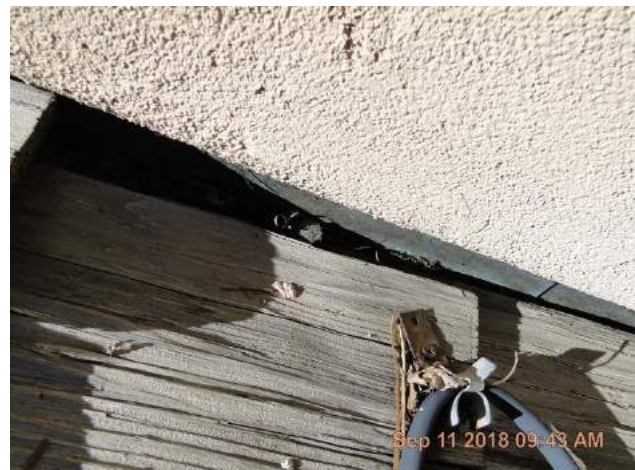
Opening at side wall flashing on front roof slope.

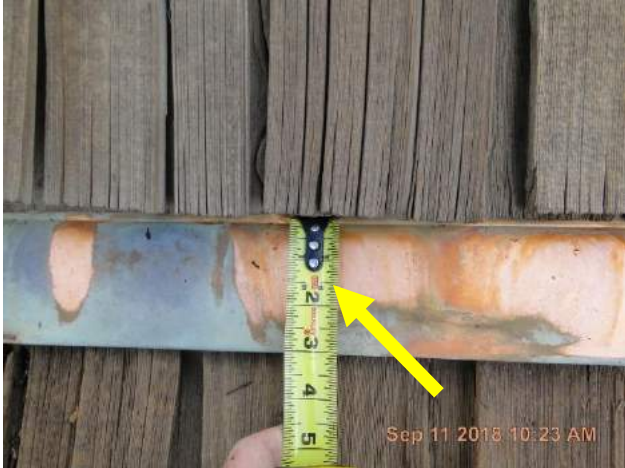
The transition flashing is the same 26-gauge copper as the other flashings and installed at the transition from the 7.5 to 3.0 slope roof. The exposed portion of the flashing that extends over the shingles is only 2 to 3-inches long and should extend at least 5-inches over the shingles. It is recommended that this flashing be replaced or extended to the specified length when the roof is replaced.

Copper transition metal is only 3-inches wide.

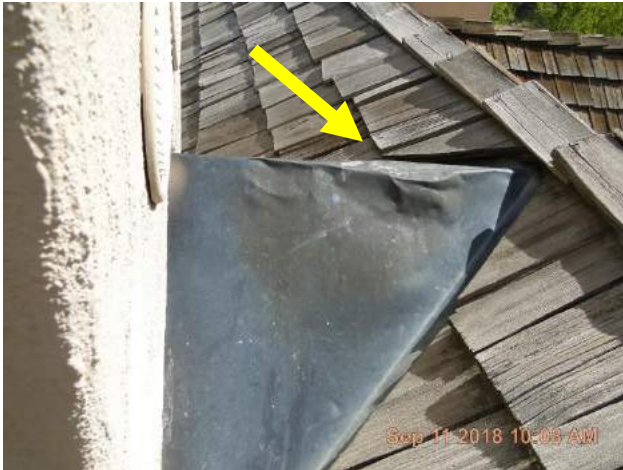
Damaged saddle / cricket.

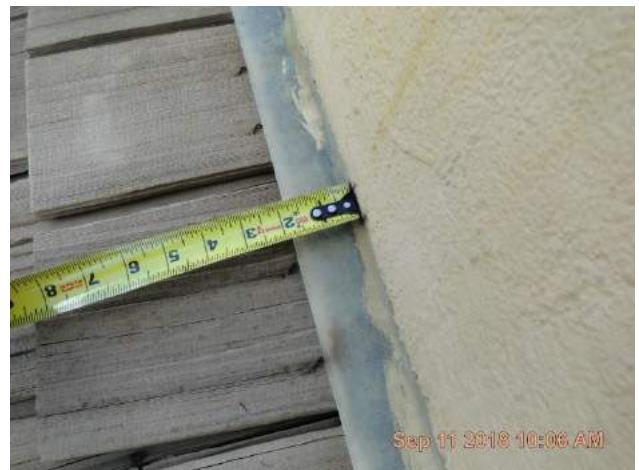
The existing head wall flashing is the same 26-gauge copper as the other flashings and installed underneath the stucco like the step flashing. This flashing appears to extend up the walls but is only 1-1/2 to 2-inches long where it extends out from the wall and over the shingles. This end of the flashing should be a minimum of 4-inches and preferably 5-inches over the shingles. It is recommended that this flashing be replaced or extended to the specified length when the roof is replaced.

Head wall flashing is only 2-inches wide

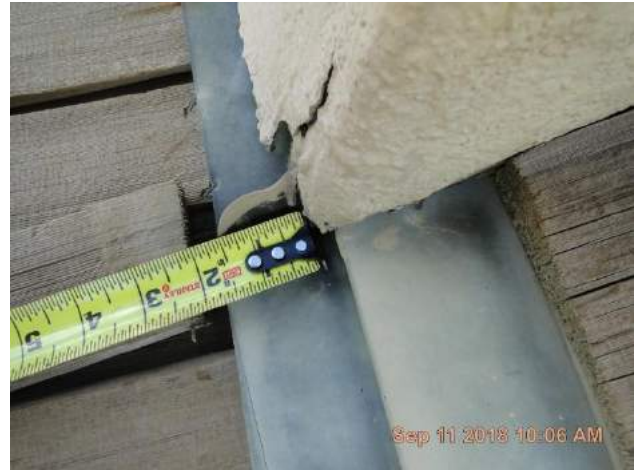
Kick-out flashings are required by current IRC code where the side wall flashing meets the head wall or eave. The existing "kick-outs" are fabricated from the 26. Gauge copper step flashing and are approximately 1-1/4 inches high x 1-1/2 inches long. These flashings should be replaced with new kick-outs that are at least 1-1/2-inches high by 2-inches long when a new roof is installed.

Close up of side wall to head wall flashing detail at chimney shows 1-1/4" high x 1-1/2" long kick-out flashing

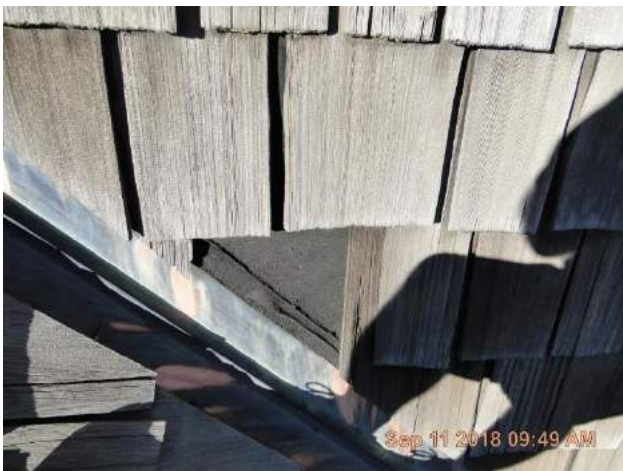
Close up shows missing shake shingle.

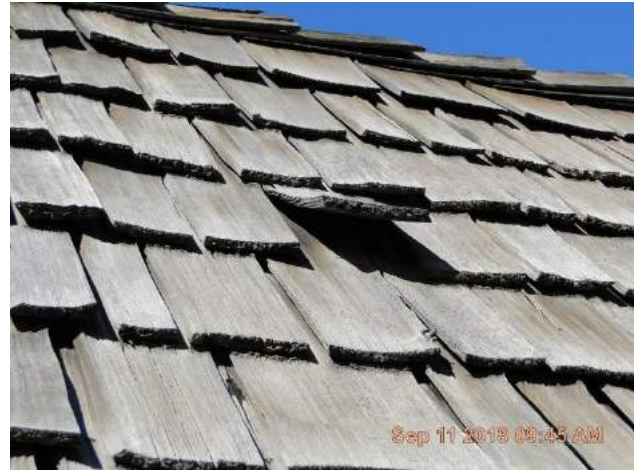
Curled shake shingle at front dormer is at higher risk to crack and separate from the roof.

Worn wood shake shingles that are curled, have multiple splits and/or holes in them should be replaced within the next 2 years with premium select or number one graded medium cedar wood shake shingles as graded by the Cedar Shake & Shingle Bureau.

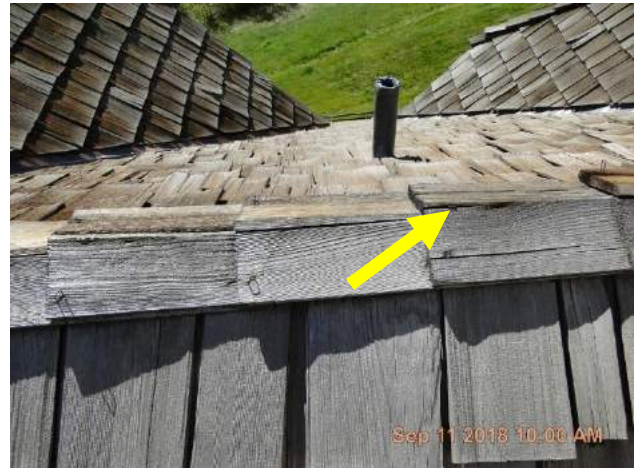
The existing ridge cap is a standard medium cedar shake shingle stapled together with 2-inch staples. There is 10 x 10 copper flashing installed under the ridge cap to further protect the ridge and Grace ice and water shield under that. The existing ridge cap has started to split and separate which is normal for a 20+ year old wood shake roof as the wood shake weathers and the staples rust over time. Approximately a third of the existing ridge cap is split or separated and should be replaced within the next year or two. It is recommended that the entire ridge cap be replaced within the next 5 years.

The ridge cap is a standard medium wood shake ridge cap that is staples together. These staples rust over time causing the ridge cap to separate and split.

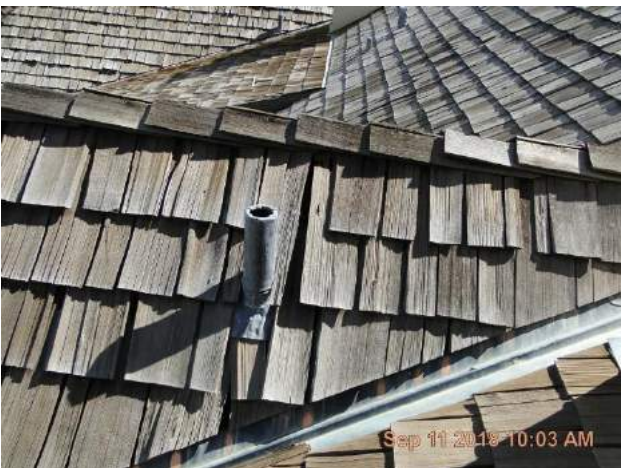
Left (west) side of front dormer shows some split shingles and others that are curled up do to the uneven Drying of wood shake that occurs over solid sheathing.

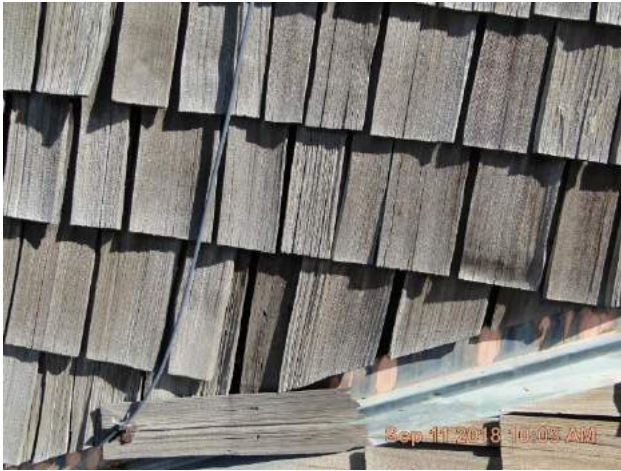
Wood shake at front dormer has detached.

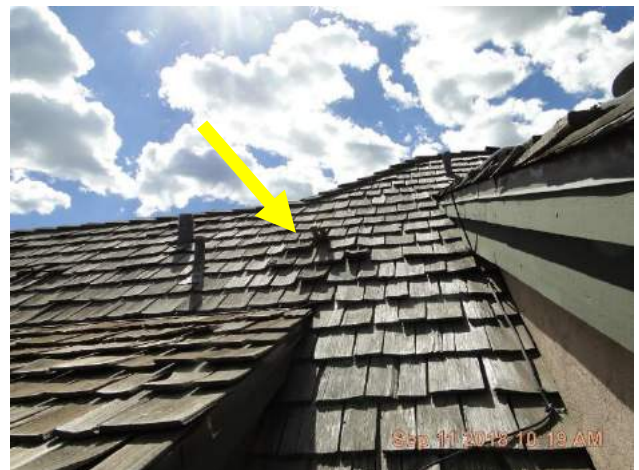
Back roof slope shows curled shake shingles.

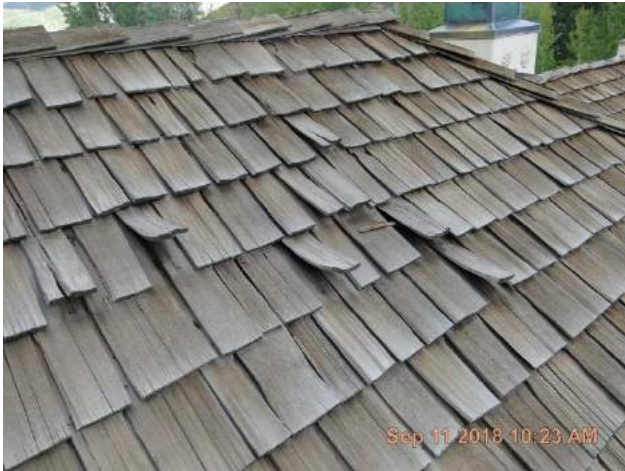
Badly curled wood shake shingle at the back roof slope.

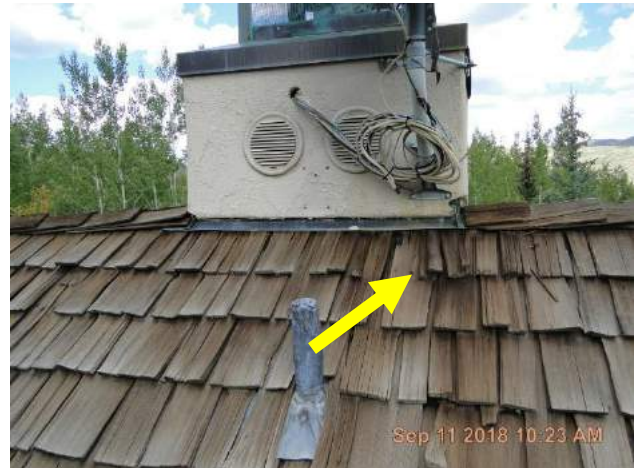
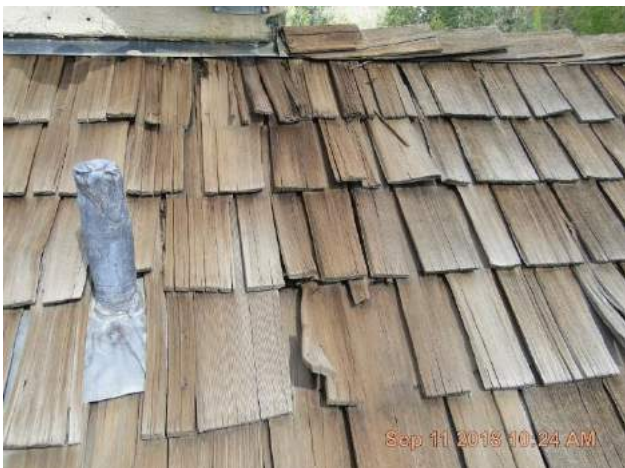
Split and worn wood shake at the back (south) slope. Wood shake shingles on the back slope are significantly thinner than the front slope due to weathering.

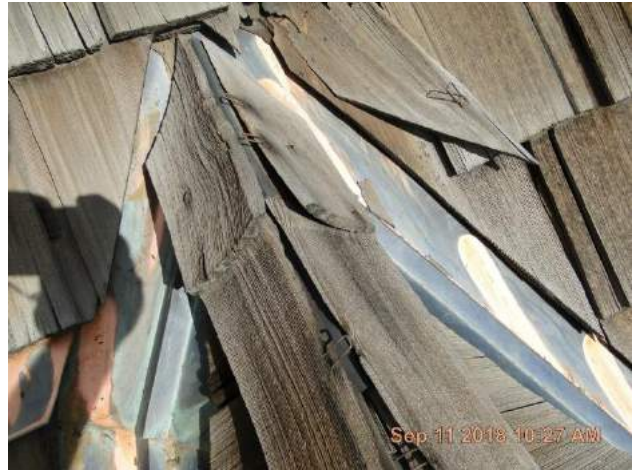
Ridge cap at back slope is split from the 2-inch staples rusting out. There is 10-inch copper step flashing installed under the wood shake at the ridge cap to protect the roof.

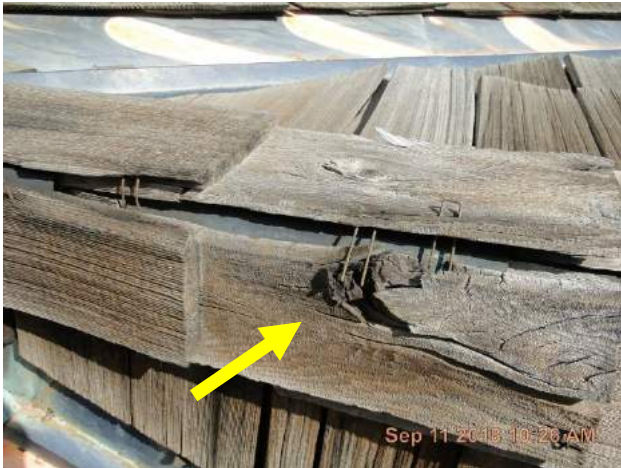
Badly split and rusted ridge shingle.

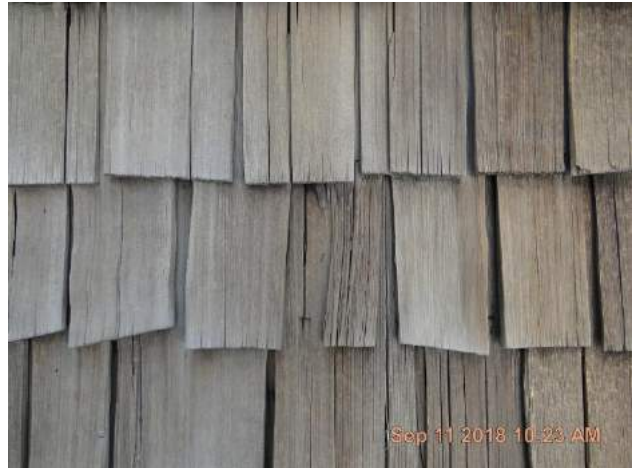
Weathered and split wood shake at the back slope.

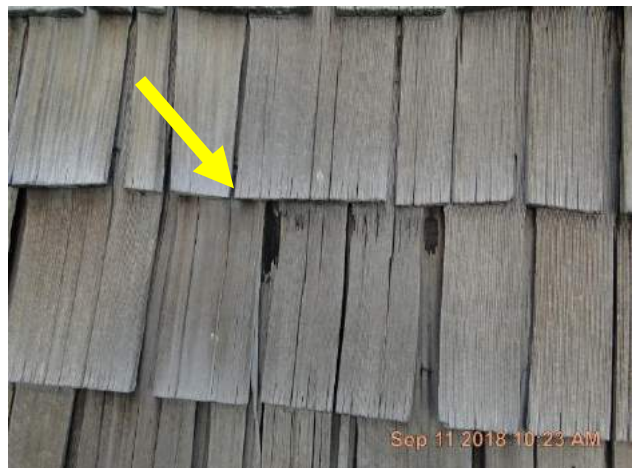
There are a significant number of wood shake shingles on the back slope with holes in them.

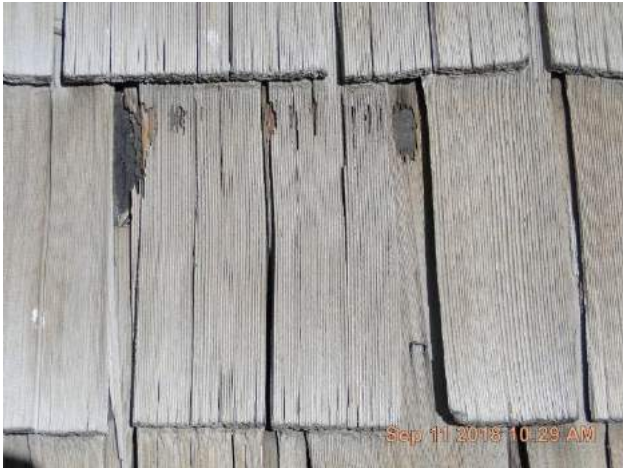
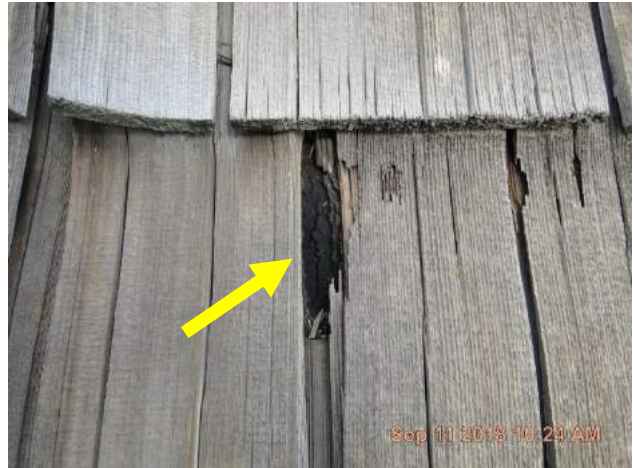
Close up of wood shake shingles with holes worn through them shows the top layer of felt has also been worn through leaving the bottom layer of ice & water shield remaining to protect the roof deck and interior.

The existing roof has a full layer of Grace ice and water shield installed at the roof deck as the waterproofing layer. The wood shake is also interlaced with 40# asphalt impregnated felt which meets code and industry standards. In areas where the underlayment is exposed it should be replaced and covered with new wood shake or 10 x 10 metal flashing.

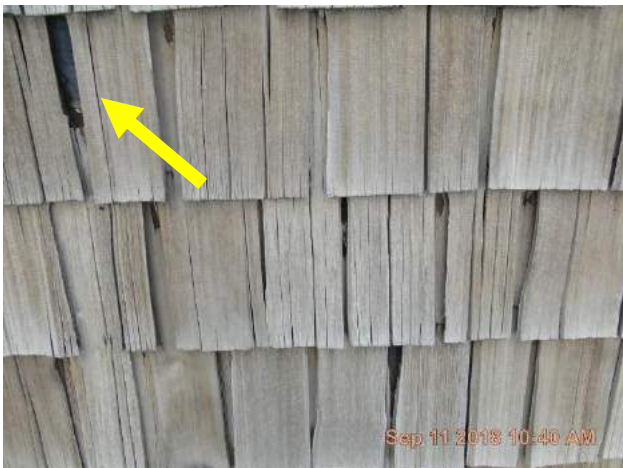
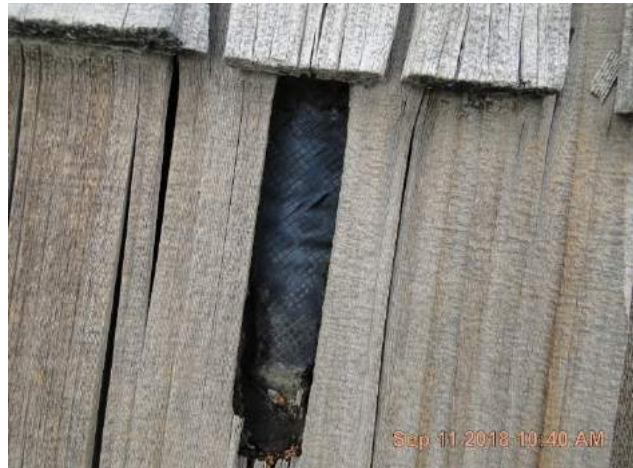
Large hole in shingles shows exposed ice and water shield below interlacing felt.

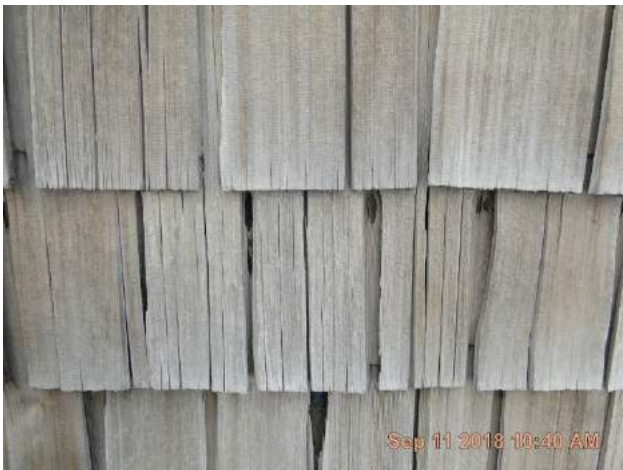
One section at the back slope shows weathered and split wood shake with 4 holes worn through them.

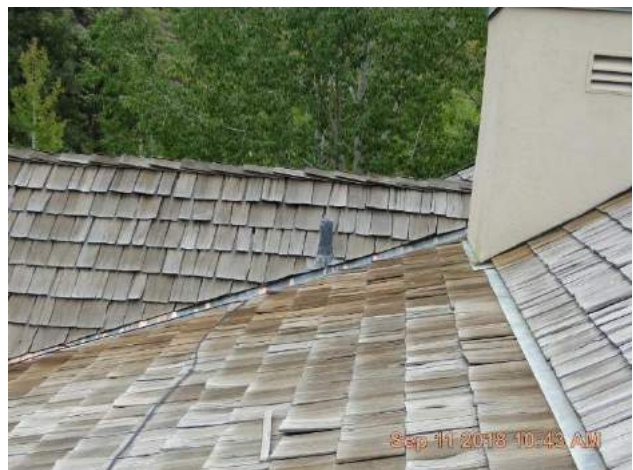
Low slope roof at the back elevation is badly worn.
