Re: Wood shake roofs at Owl Creek Townhomes

Inspect the roofs at Owl Creek Homes in Snowmass Village, Colorado and prepare a brief report to document the existing condition of the roofs along with the expected life of the various roof components. There is a total of 31 roofs within this subdivision. In order to accomplish this, I inspected the subject roof located at 916 Burnt Mountain Drive within the development as a typical example of the condition of the existing roofs.

Owl Creek Homes

916 Burnt Mountain Drive Snowmass Village, CO 81615

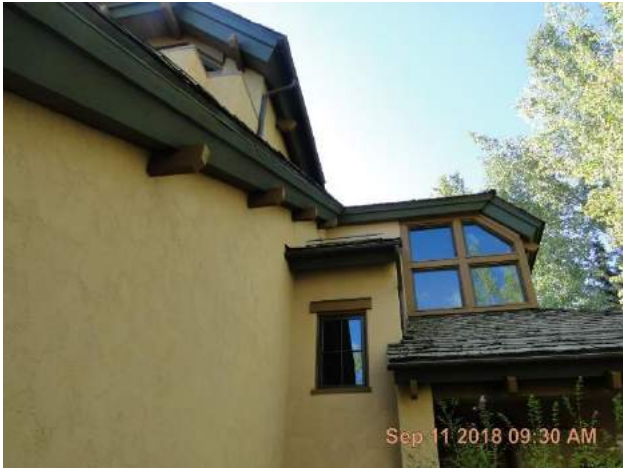
Front (north) elevation right side.

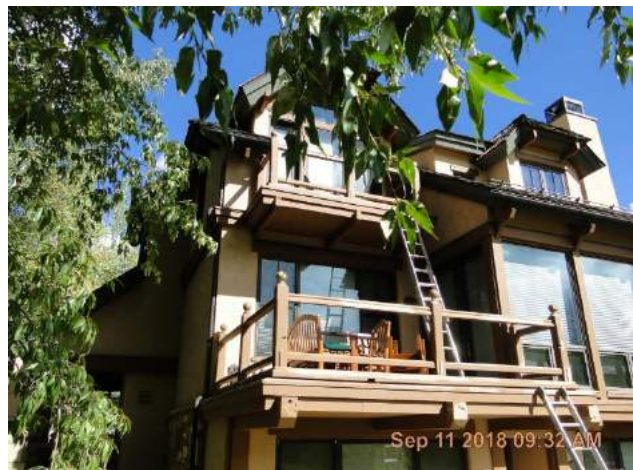
Back (south) elevation at left end.

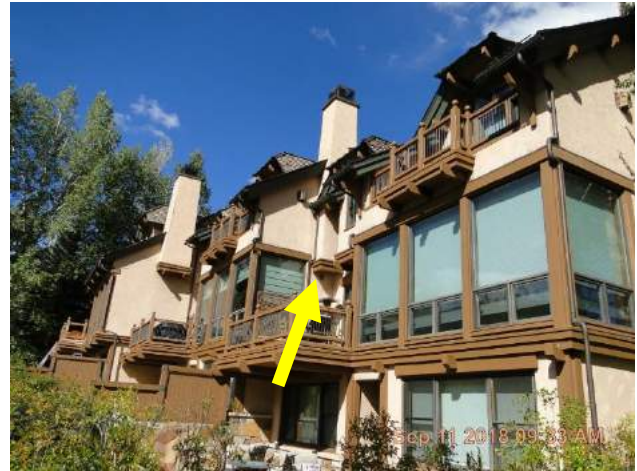
Back (south) elevation at right end.

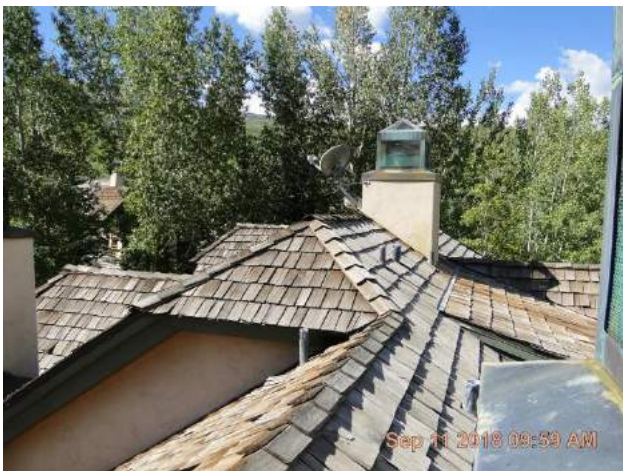
Top of roof from the east end facing west.

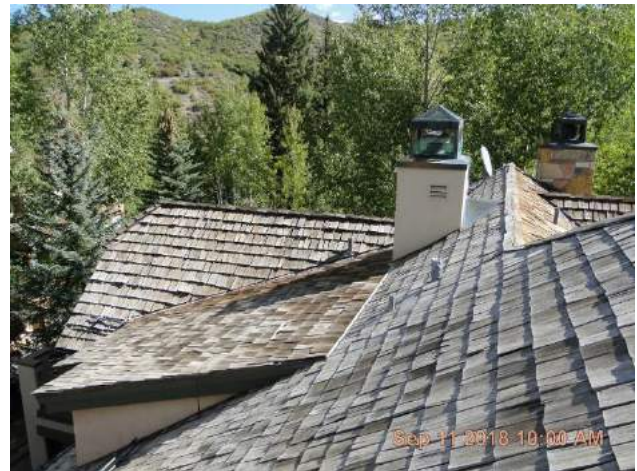
Top of roof from the middle facing east.

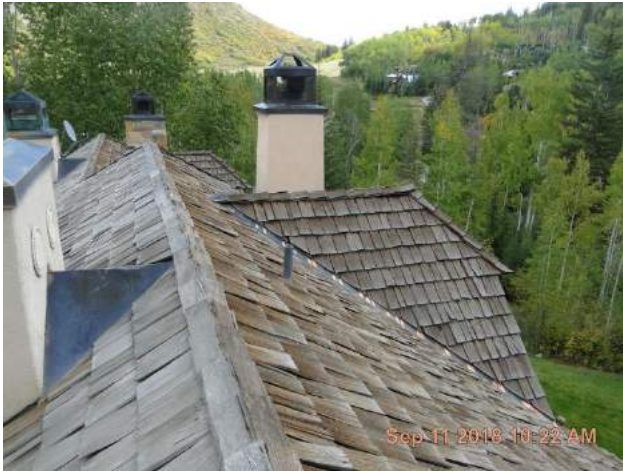
Top of roof from the west end facing northeast.

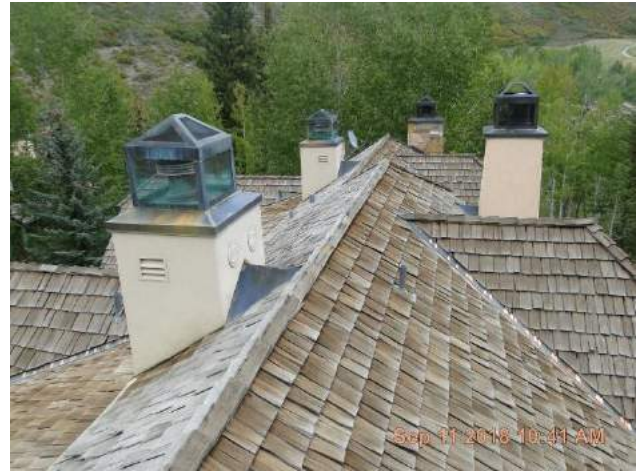
Top of roof from the west end facing east.

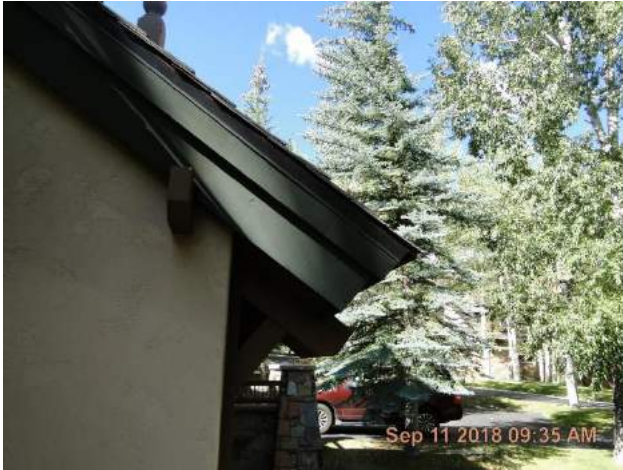
Rake edge at front left gable.

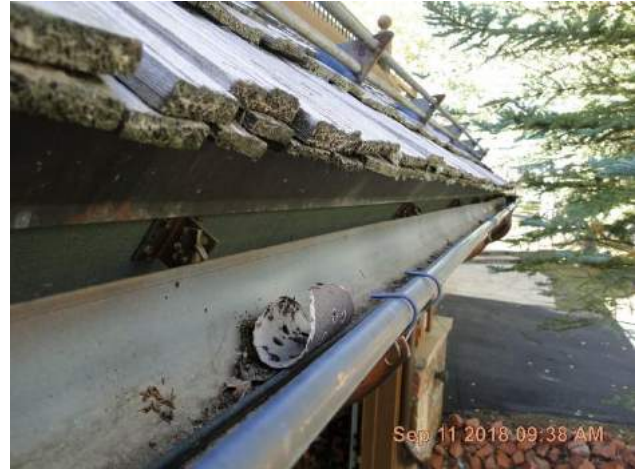
- 1) **Gutters:** The existing gutters are a 6.5-inch half round copper gutter supported with copper brackets. These gutters are in good condition and are expected to last 10 years or more. These gutters will need to be detached and reset during a reroof.
- 2) **Downspouts:** The existing downspouts are 3-inch round copper with copper straps. These downspouts are in good condition and are expected to last 10 years or more.

Front eave over garage shows drip edge and half Round copper gutter.

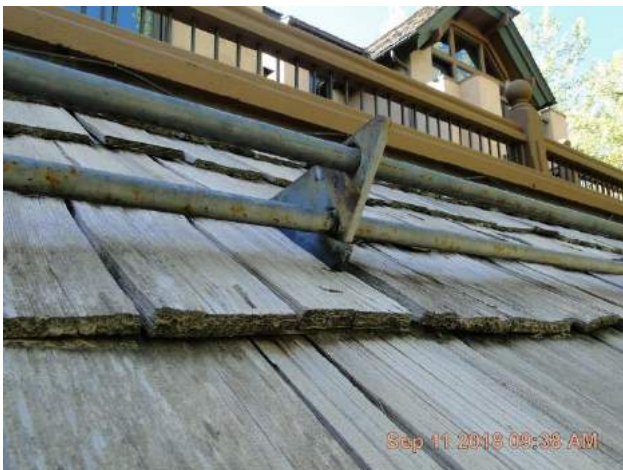
The existing snow fence is comprised of 2 x 1-inch copper tubes secured by copper brackets installed 36 inches on center. There is one row of snow fence above most eaves installed 24-inches up from the end of the roof slope. The snow fence is in good condition and expected to last 10 years or more.

Snow fence at the front lower roof.

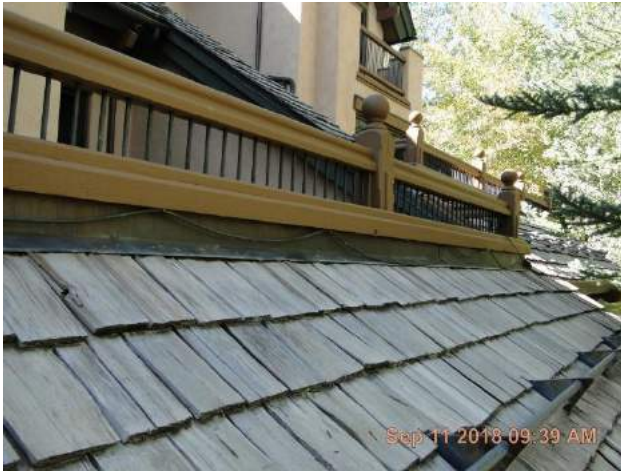
Deck with head wall flashing at the front lower roof.

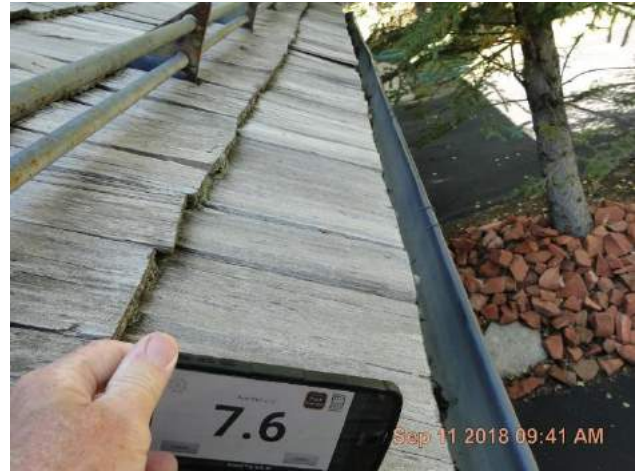
Roof slope reads at 7.5 in 12 slope which is a steep slope roof.

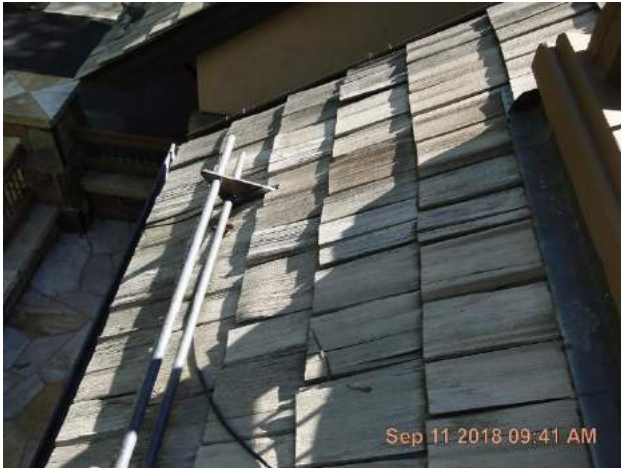
Front lower roof below deck shows head wall flashing and snow fence.

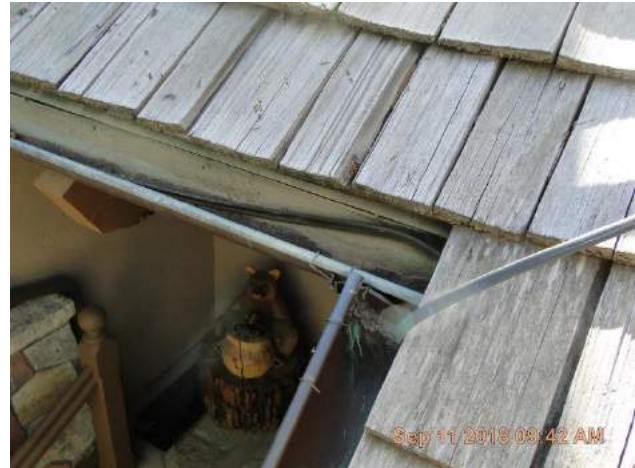
Front eave over entrance.

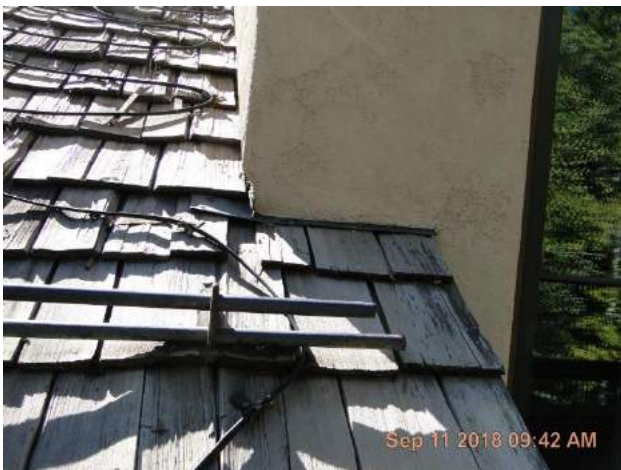
Front roof head and side wall at left of deck.

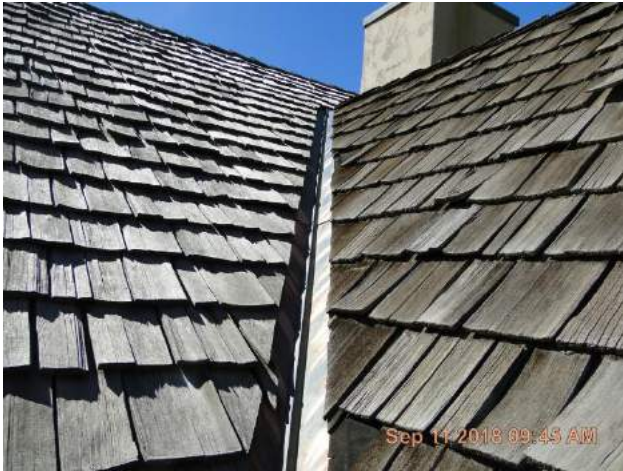
Copper W-valley at front slope where it meets the large dormer at the right (northwest) side.

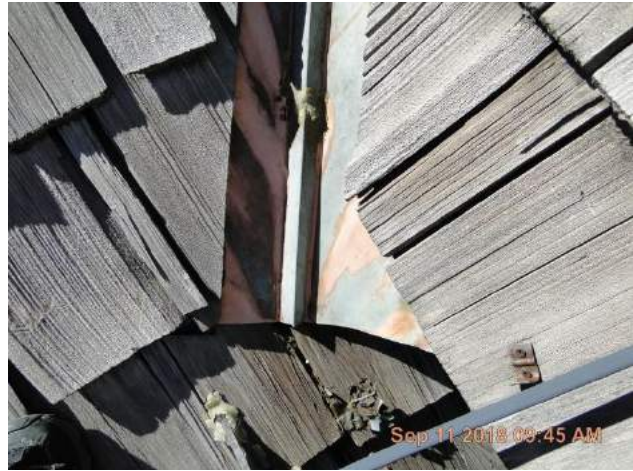
End of copper valley at side wall.

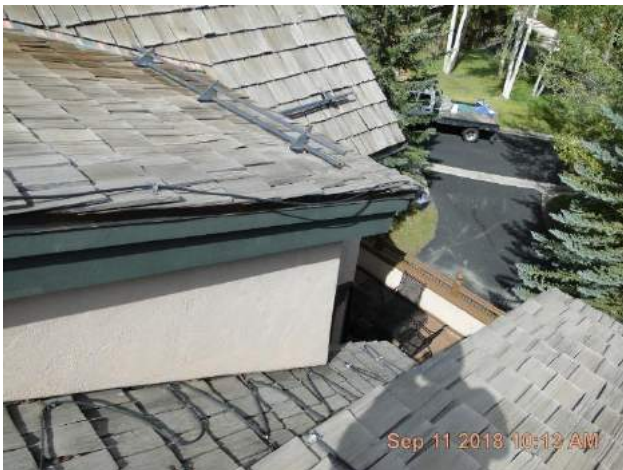
The existing heat tape is a heavy-duty self-regulating heat cable. The heat cable is installed at the eaves, valleys and side walls and is secured with copper brackets. A controller and sensors may exist but were not located. The heat cable appears to be in good operating condition but should be checked for performance by testing the resistance of each line to ensure they are functioning properly. Heat tape and related appurtenances should be checked every 2 to 3 years. The existing heat cable is expected to perform 5 years or more with proper maintenance.

Front side wall view from top of roof shows fascia at gables, heat tape and side wall.

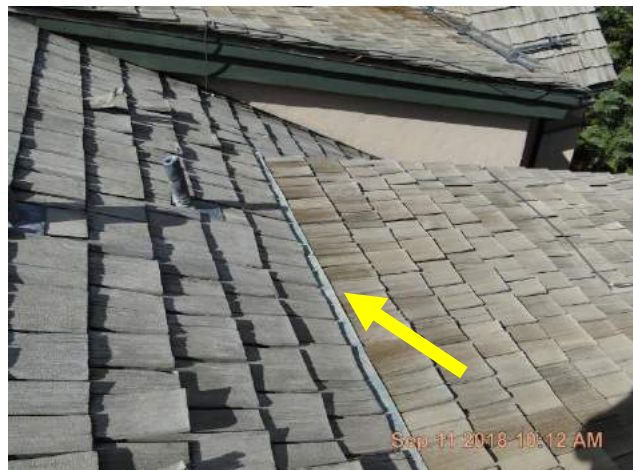
The transition flashing is the same 26-gauge copper as the other flashings and installed at the transition from the 7.5 to 3.0 slope roof. The exposed portion of the flashing that extends over the shingles is only 2 to 3-inches long and should extend at least 5-inches over the shingles. It is recommended that this flashing be replaced or extended to the specified length when the roof is replaced.

Transition from steep 7.5 slope roof to 2.8 slope roof.

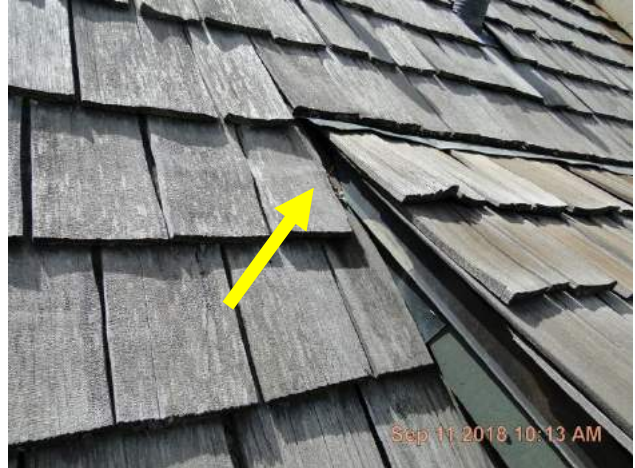
Front slope side wall at lower slope dormer. Shows The side wall flashing and rake edge metal.

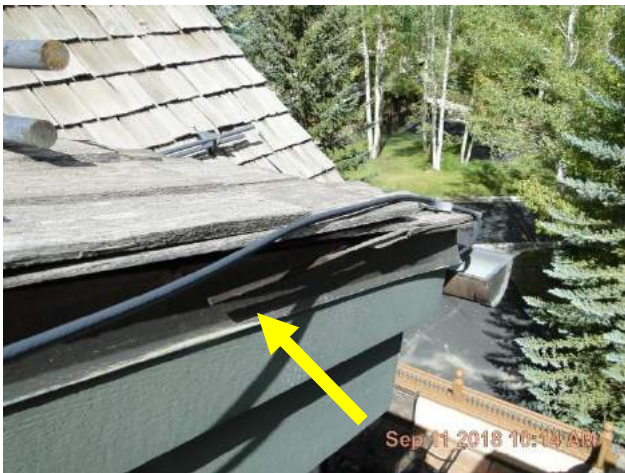
Rake edge metal at front dormer shed roof.

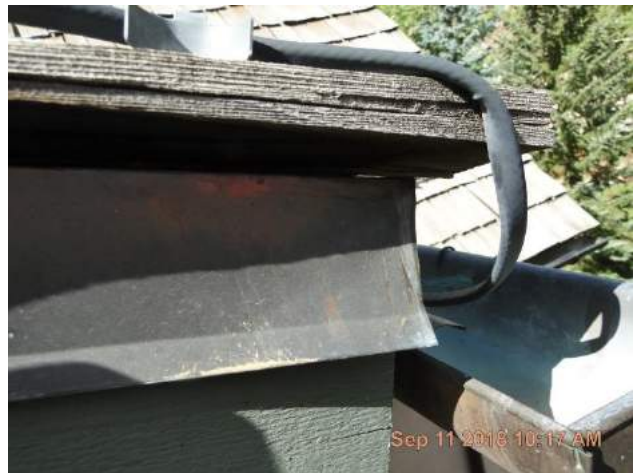
Close up of copper rake edge metal.

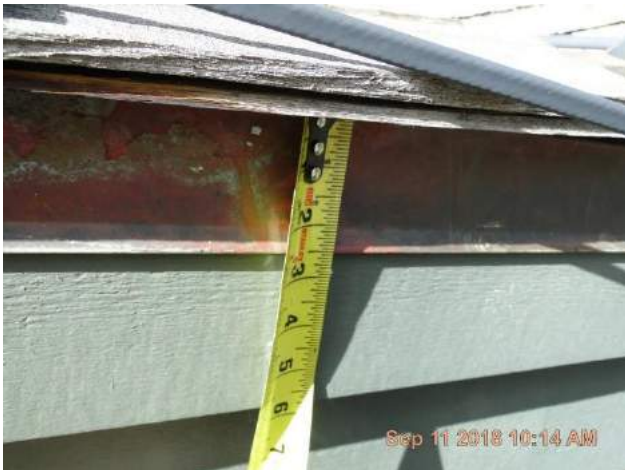
Copper drip edge metal is 2.5" high at the eaves.

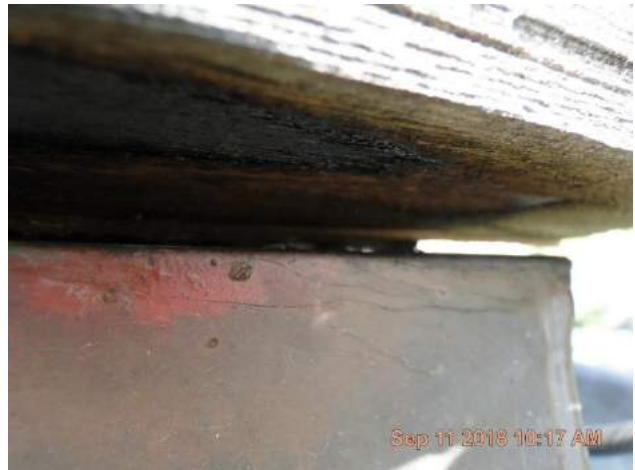
Close up of copper drip edge and wood shake starter.

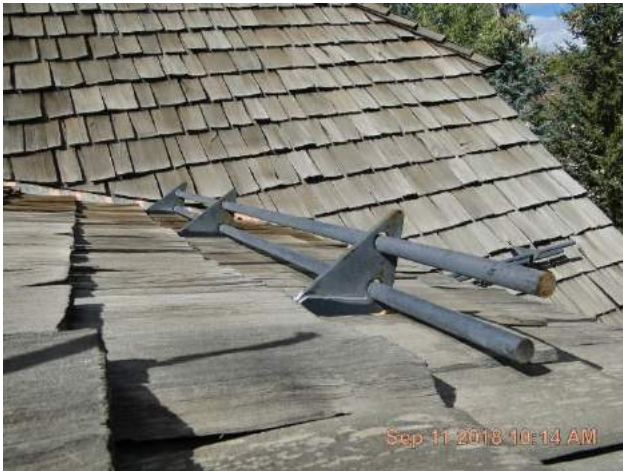
Snow fence installed on front dormer shed roof.

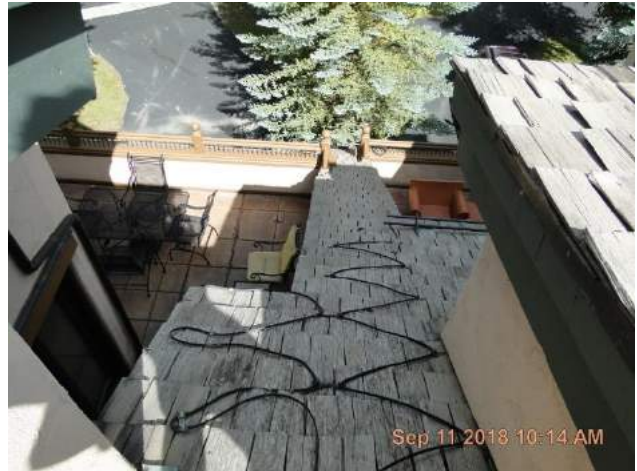
Front roof slope between decks shows heat tape.

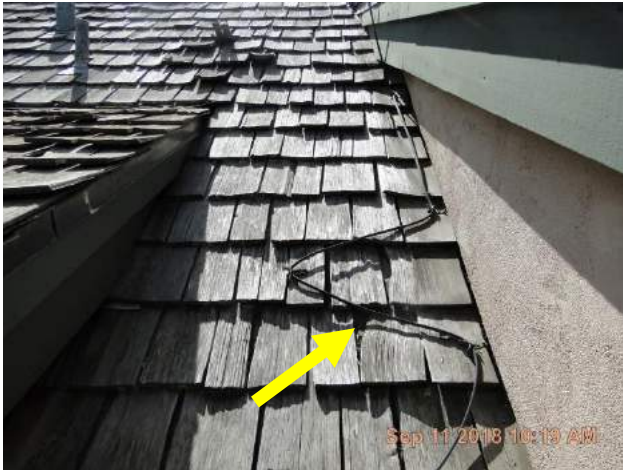
Side wall right of the front dormer shed roof with heat tape installed.

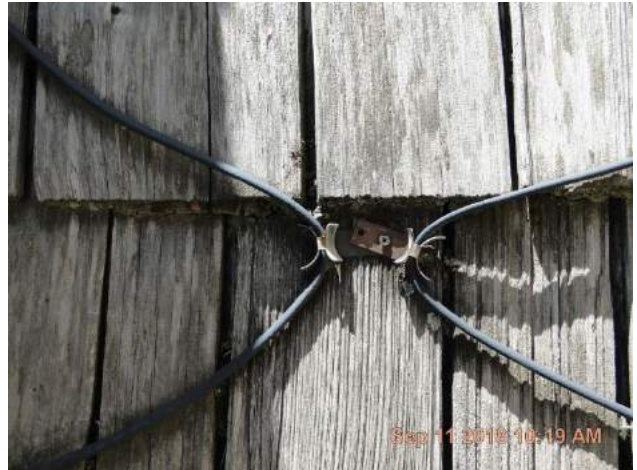
Heat tape is attached with copper clips.

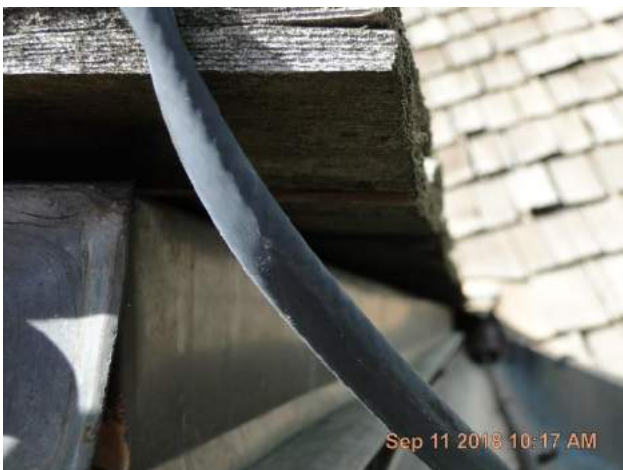
Close up of heat tape / cable also shows a gap at the rake metal to drip edge transition.

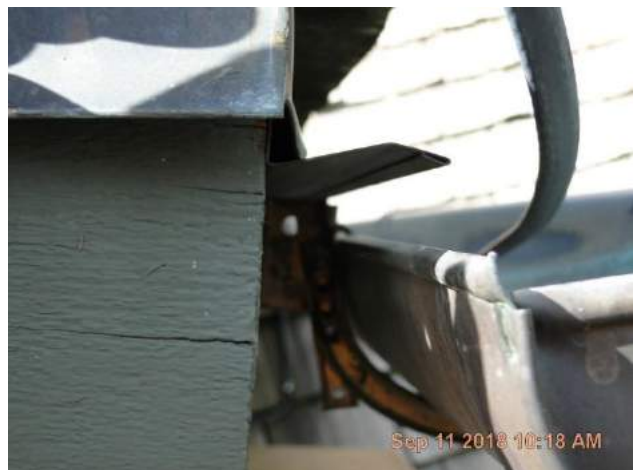
Close up of gable to eave transition shows close up of gutter and gutter attachment.

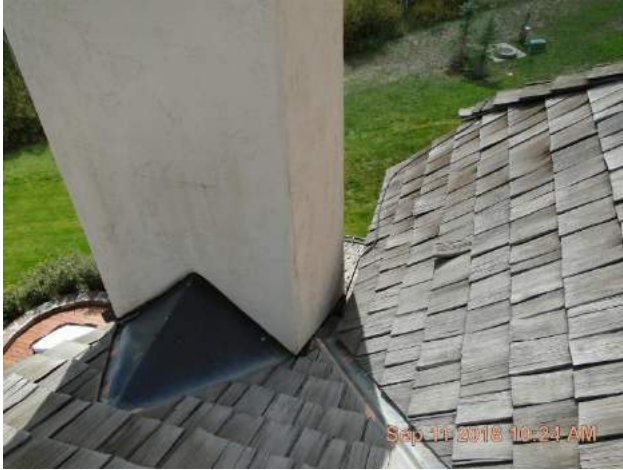
Chimney with copper saddle / cricket. Valley dead ends at the chimney side wall.

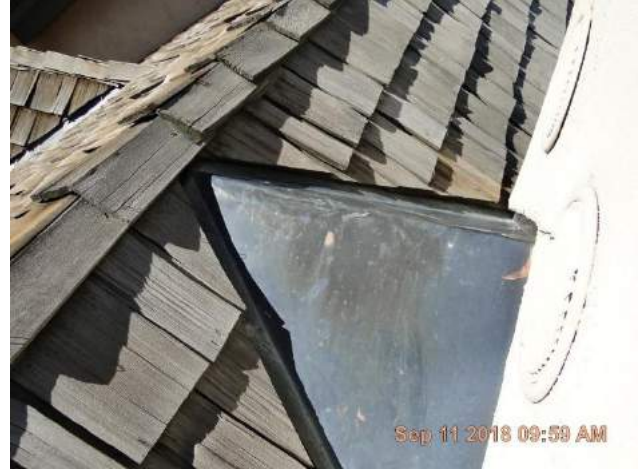
Close up of copper saddle / cricket.

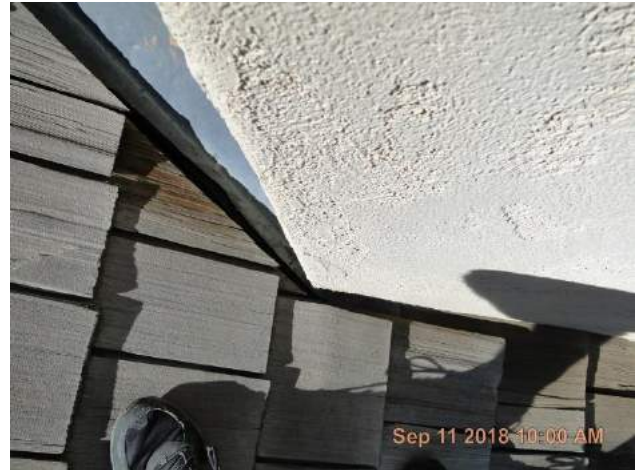
Closeup of chimney at cricket valley to side wall.

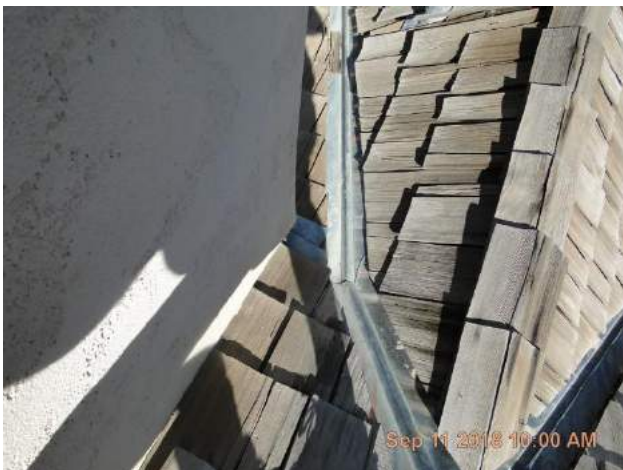
Copper valley at chimney side wall.

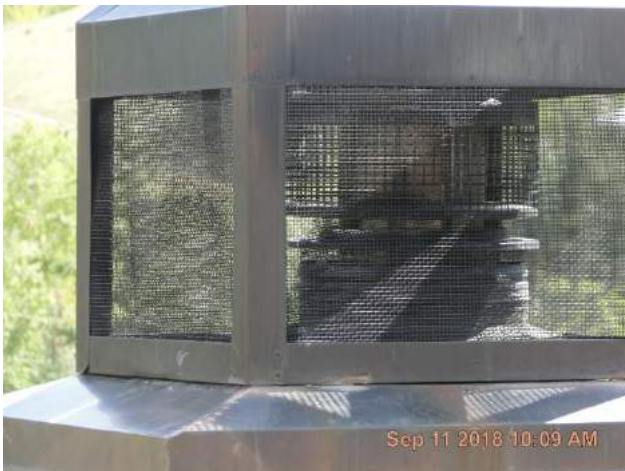
Closeup of copper screened cage at chimney flue.

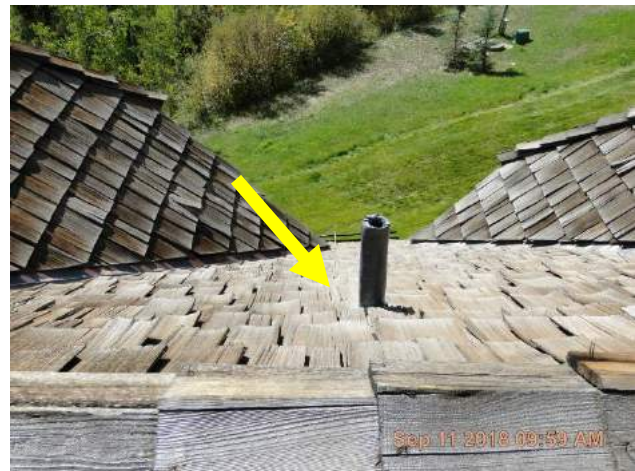
Roof slope at back elevation from top of roof shows lead pipe jack.

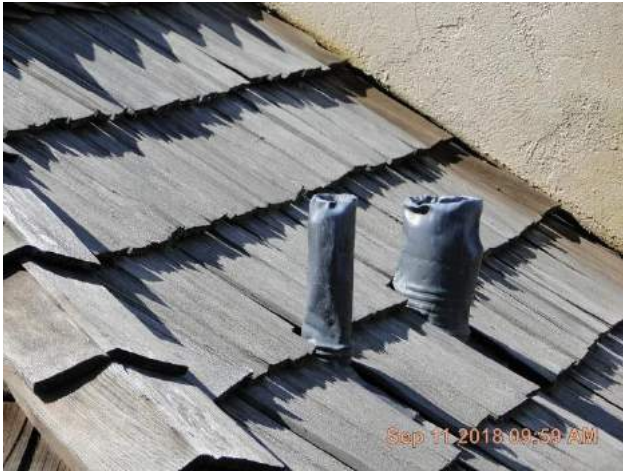
Lead pipe vent flashings (pipe jacks).

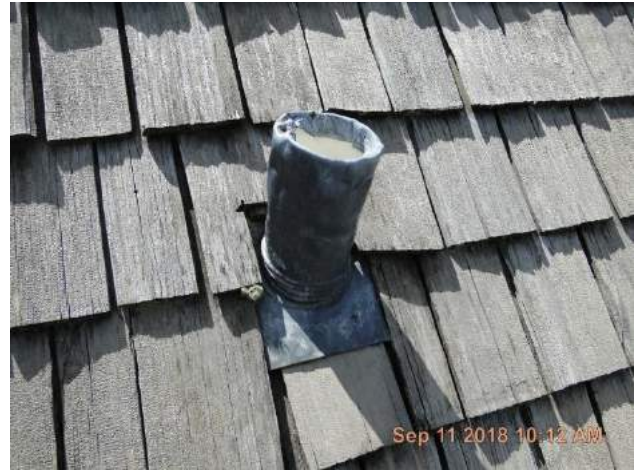
Close up of lead pipe jack.

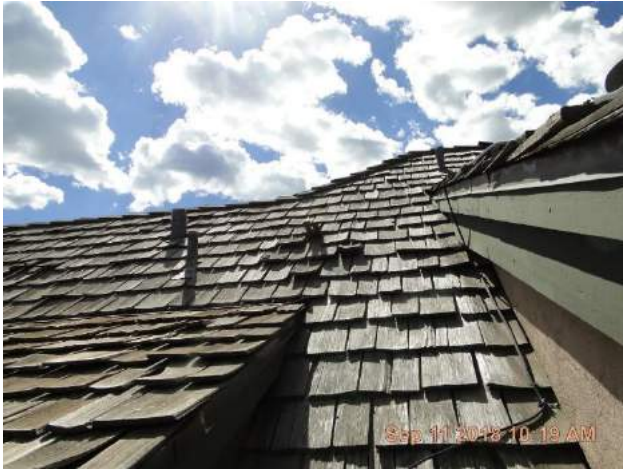
Wood shake shingles at front roof slope.

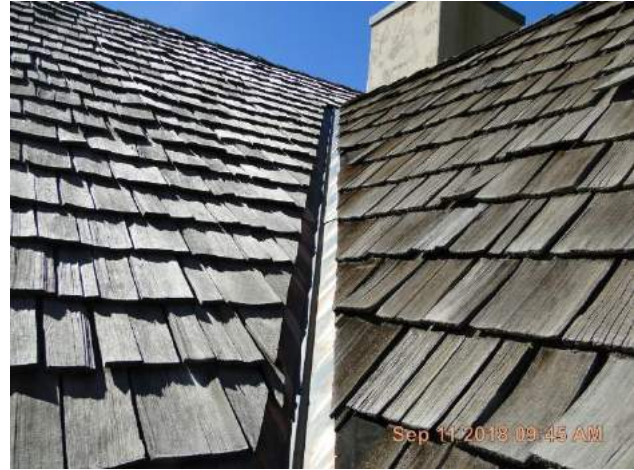
Front roof slope at steep 10/12 front dormer.

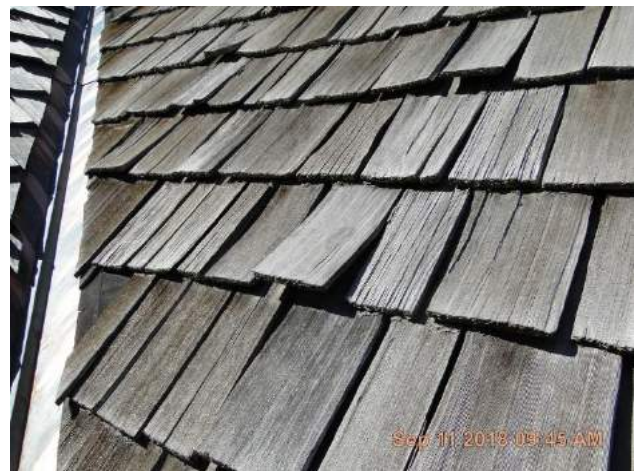
Left (east) slope of large front dormer roof to the right of the front entrance.

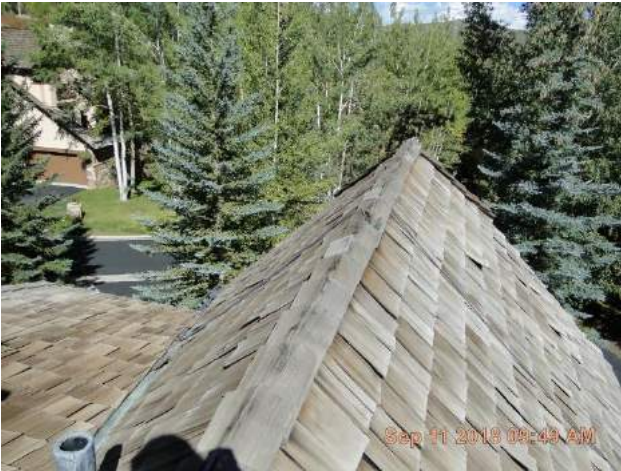
Front steep slope dormer facing northeast

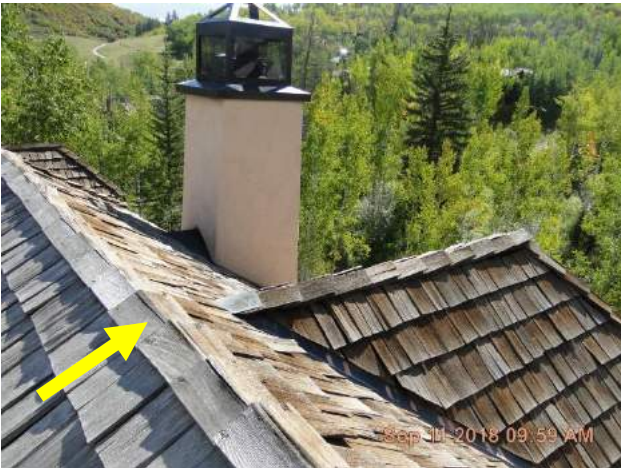
Top of roof facing south shows ridge cap.

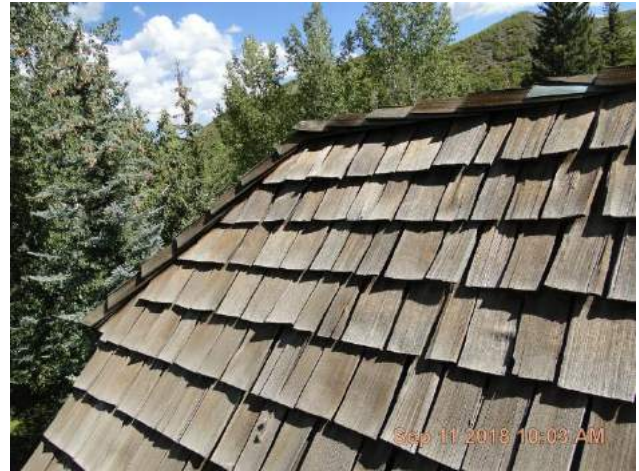
Left (west) slope of rear dormer.

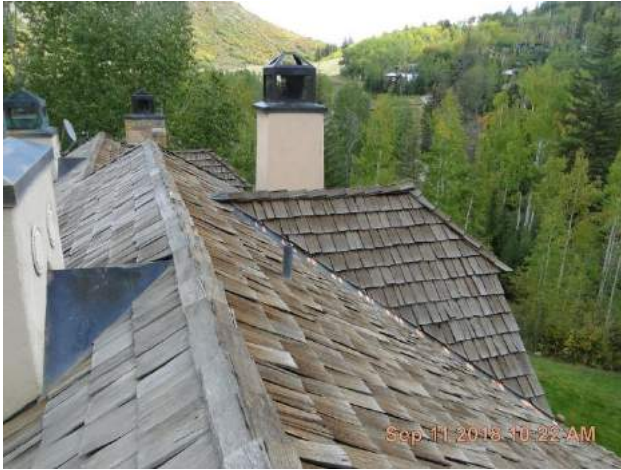
Top of roof toward the middle facing south

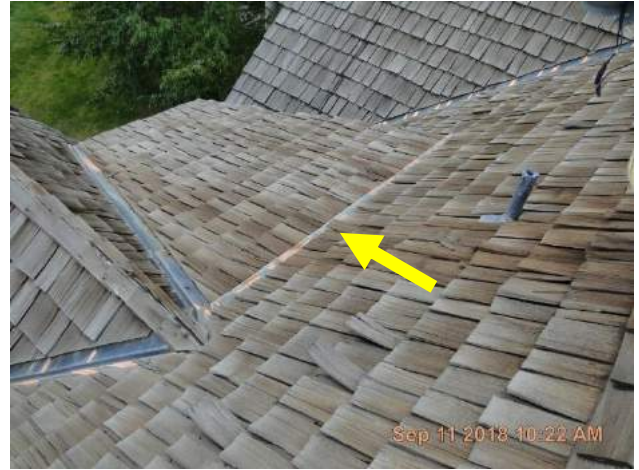
Transition from steep to lower slope roof at the back (south) elevation.

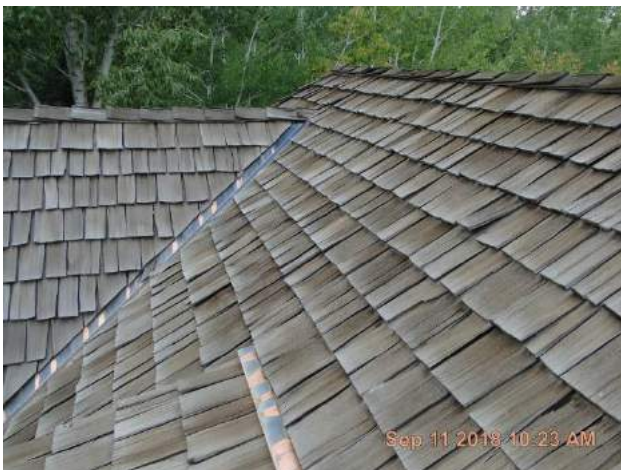
Back roof slope.

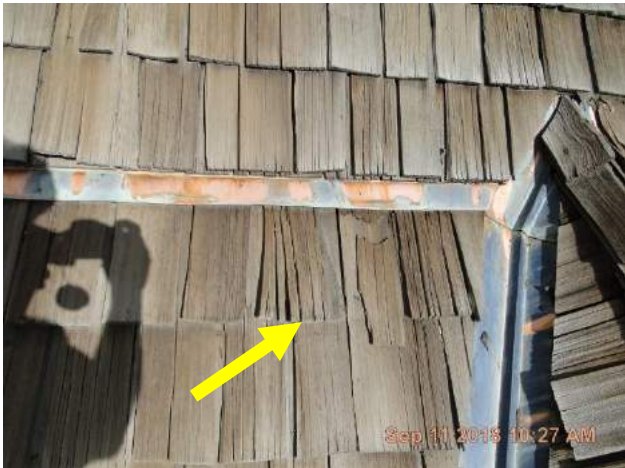
There are approximately 7 missing shingles on the roof and multiple wood shake shingles that are curled, split and that have holes worn through them. This is especially true on the back (southern) slope where the wood shake shingles are worn thin with over 350 with multiple splits and up to 250 or more with holes worn through the wood shake leaving exposed felt and/or ice and water shield. The front, right and left roof slopes have some curled and split wood shake shingles, but none were found with holes. The wood shake shingles in these areas are significantly thicker and in better condition. It is common for wood shake shingles to wear more quickly on the slopes with southern exposure. Many of the cedar shake ridge cap shingles are split and separated where the staples holding them together have rusted. This is a normal occurrence on wood shake roofs over 15 years old. The ridge cap shingles are also worn more significantly on the back southern facing slopes.

Back (south) elevation shows a considerable number of split shingles.

The back, southern, roof slope should be repaired or “tuned up” within the next couple of years while the front, left and right roof slopes need minor repairs. The wood shake shingles on the remaining roof slopes are expected to last from 5 to 10 years before needing to be replaced. You will find more details in the following inspection report along with my recommendations.

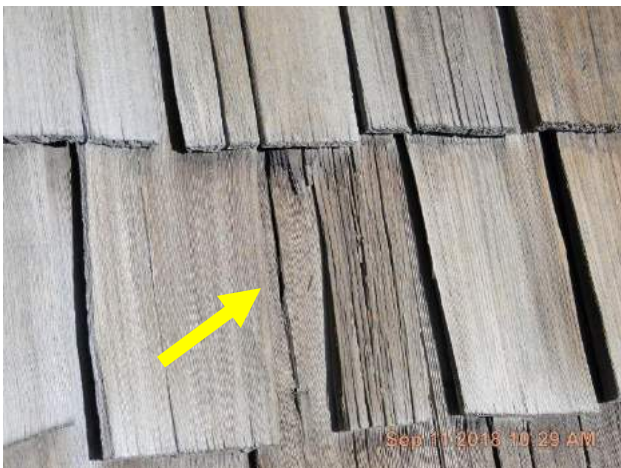
Badly split wood shake on back slope.
