Re: Wood shake roofs at Owl Creek Townhomes

Inspect the roofs at Owl Creek Homes in Snowmass Village, Colorado and prepare a brief report to document the existing condition of the roofs along with the expected life of the various roof components. There is a total of 31 roofs within this subdivision. In order to accomplish this, I inspected the subject roof located at 916 Burnt Mountain Drive within the development as a typical example of the condition of the existing roofs.

Owl Creek Homes

916 Burnt Mountain Drive Snowmass Village, CO 81615

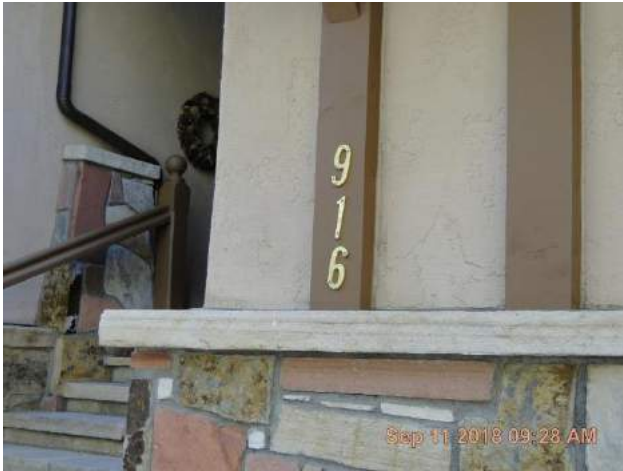
916 Burnt Mountain Drive - Owl Creek Townhomes.

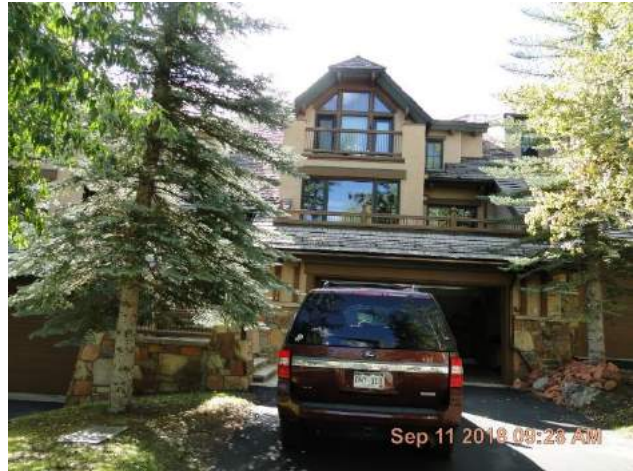
Front (north) elevation.

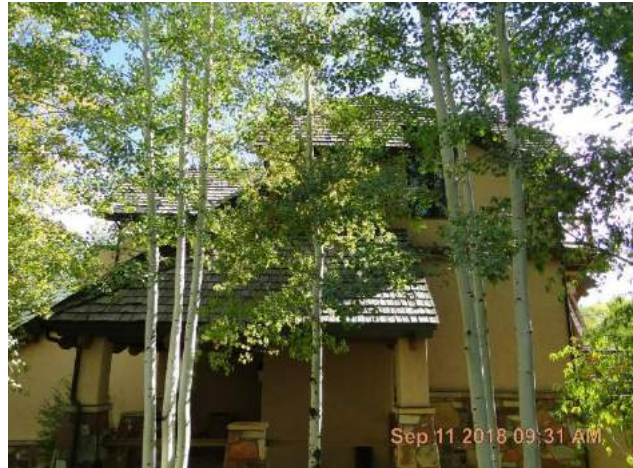
Right (west) elevation.

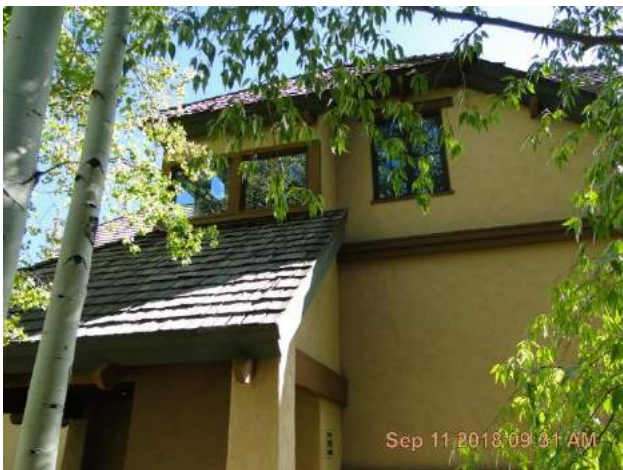
Right (west) elevation.

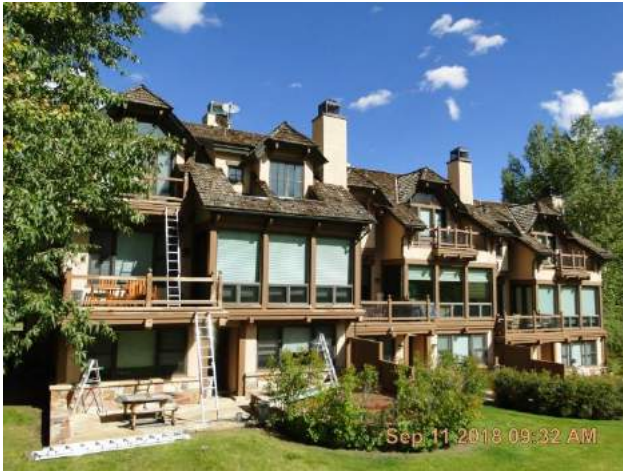
There are approximately 7 missing shingles on the roof and multiple wood shake shingles that are curled, split and that have holes worn through them. This is especially true on the back (southern) slope where the wood shake shingles are worn thin with over 350 with multiple splits and up to 250 or more with holes worn through the wood shake leaving exposed felt and/or ice and water shield. The front, right and left roof slopes have some curled and split wood shake shingles, but none were found with holes. The wood shake shingles in these areas are significantly thicker and in better condition. It is common for wood shake shingles to wear more quickly on the slopes with southern exposure. Many of the cedar shake ridge cap shingles are split and separated where the staples holding them together have rusted. This is a normal occurrence on wood shake roofs over 15 years old. The ridge cap shingles are also worn more significantly on the back southern facing slopes.

Back (south) elevation.

The back, southern, roof slope should be repaired or “tuned up” within the next couple of years while the front, left and right roof slopes need minor repairs. The wood shake shingles on the remaining roof slopes are expected to last from 5 to 10 years before needing to be replaced. You will find more details in the following inspection report along with my recommendations.

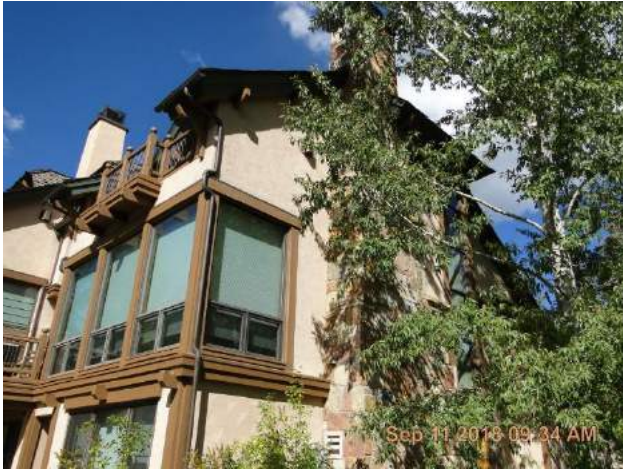
Left (east) elevation at southeast corner.

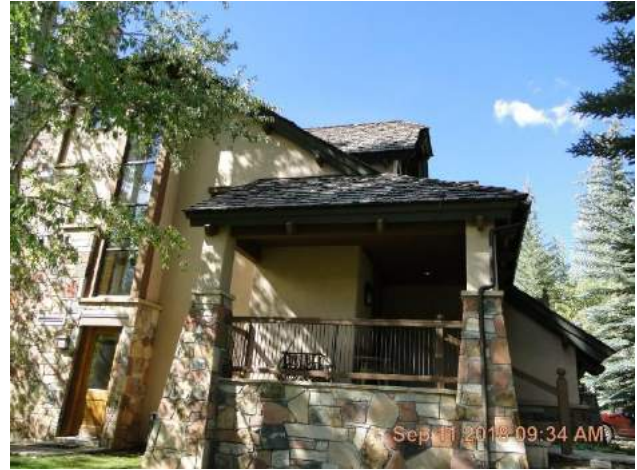
Left (east) elevation at right end.

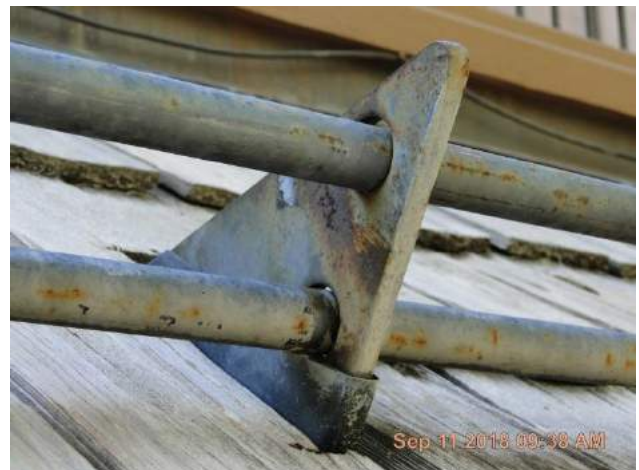
Closeup of snow fence bracket.

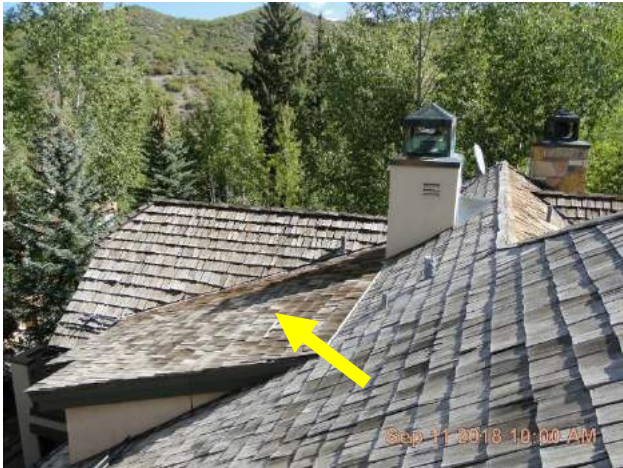
There are several lower slope dormer shed roofs that register at a roof slope of 2.5 to 3 requiring double felt.

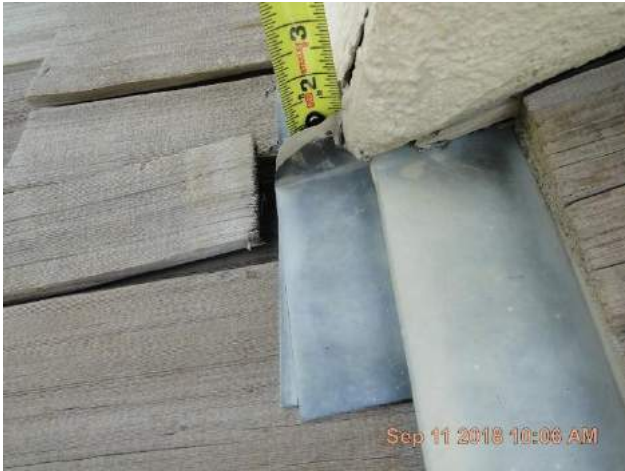
Close up of side wall to head wall flashing detail at chimney shows 1-1/4" high x 1-1/2" long kick-out flashing

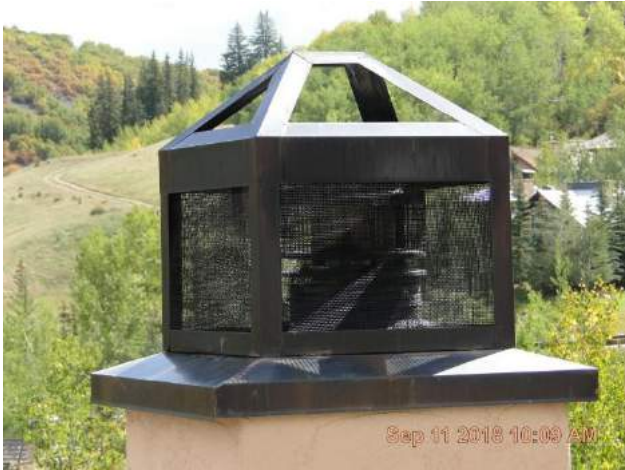
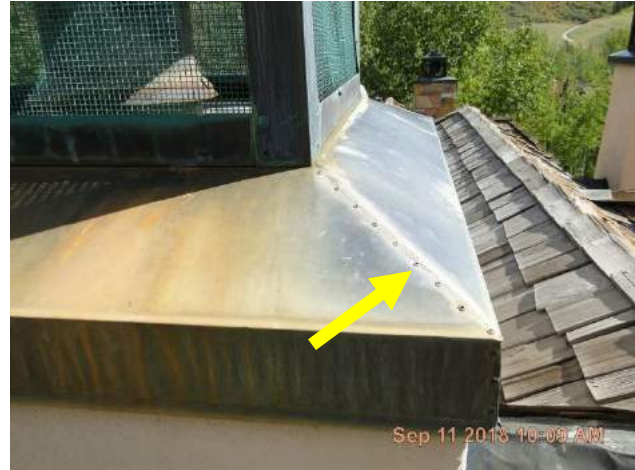
Copper chimney chase with screened cage around chimney flue. Chase is riveted and soldered together.

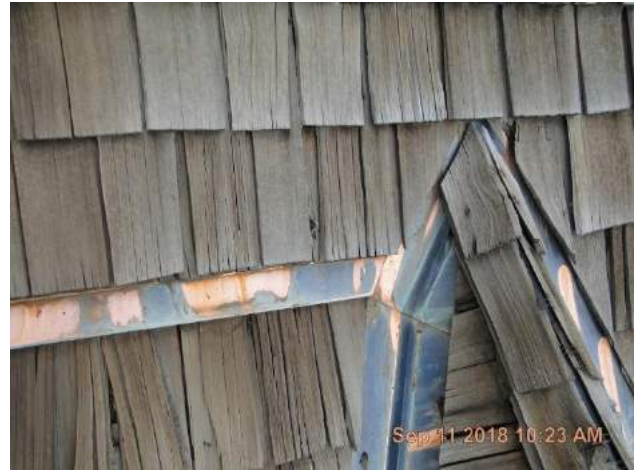
Copper transition metal and W-Valley metal at back, rear dormer

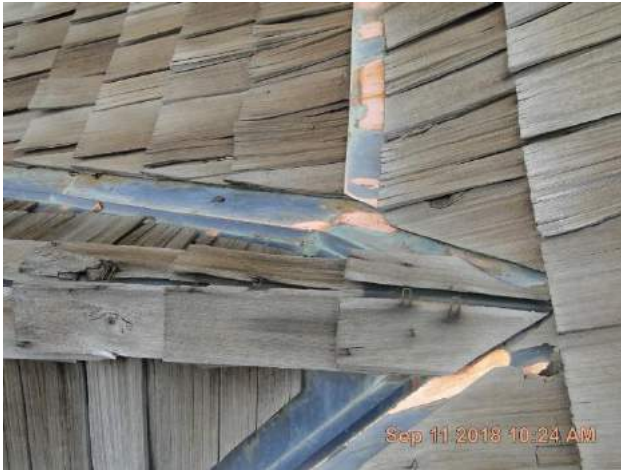
Ridge cap at back slope is split from the 2-inch staples rusting out. There is 10-inch copper step flashing installed under the wood shake at the ridge cap to protect the roof.
